# Manhole Inspection Summary

Manhole # S35U\_\_057MH

Insp Date: **2/14/08 10:41 AM**

**Location** Address: **1452 light st**

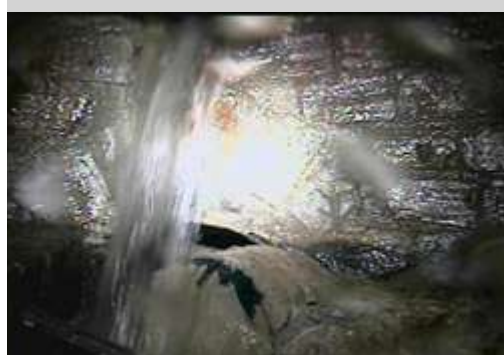
Defect 3

Condition: ☐ Sound ☐ Cracked ☐ Root Intrusion ☐ Deteriorated ☐ Leaks ☒ **Debris**

channel debris

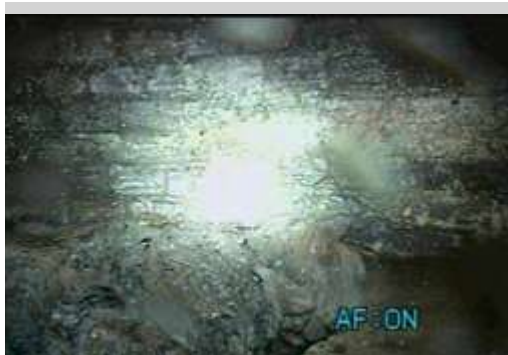
Defect 2

Condition: ☐ Sound ☐ Cracked ☐ Root Intrusion ☐ Deteriorated ☐ Leaks ☒ **Debris**

bench debris

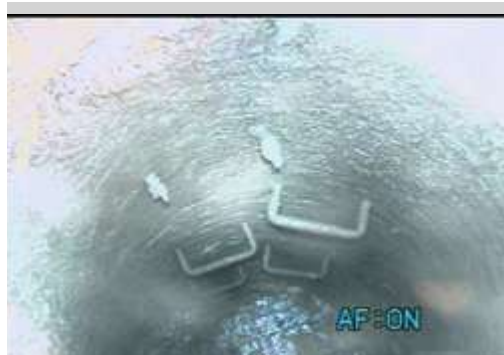
Defect 1

Count: **7** Missing: **2** ☒ **Corroded**

missing/corroded steps

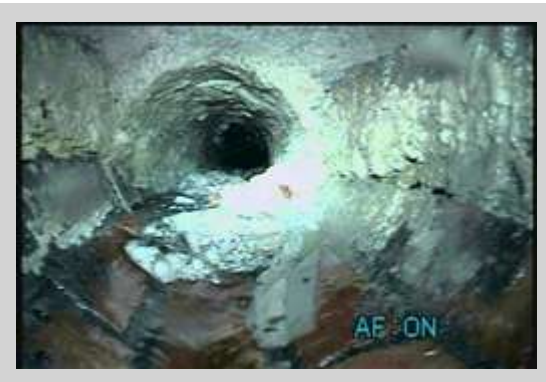
10 in. Circular Gravity Sewer  
Pipe In @ 6 O'Clock

Pipe Height: 0 (in.) Direct  
Pipe Material: **Clay** ☐ Pipe Lined  
Invert Depth: **11.60** (ft.) Flow Characteristics: **Fast**  
Deposits: ☐ None ☐ Mud ☐ ~~Sludgy~~ ☐ Debris ☒ Grease  
Silt Depth: 2 (in.) Deposits Extent: **Medium**  
Infiltration: **None** Pipe Seal Cond: **Unknown**

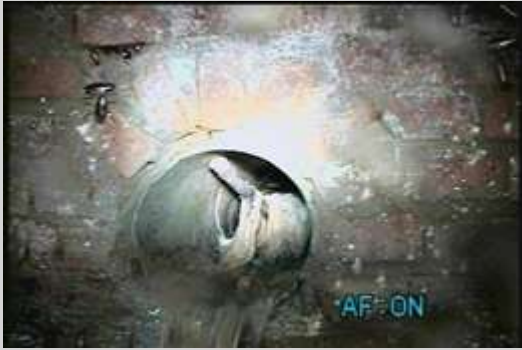
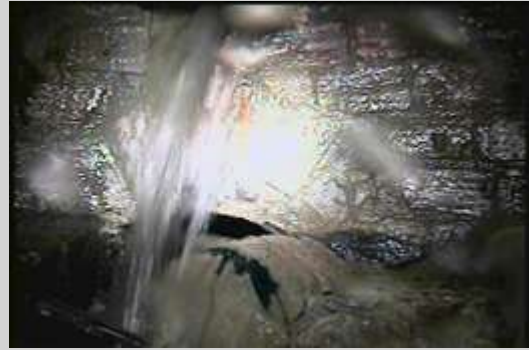
Pipe In @ 9 O'Clock

Deposits: ☐ None ☐ Mud ☒ **Sludge** ☐ Debris ☒ **Grease**

Silt Depth: **4** (in.) Deposits Extent: **Medium**

Drop Condition: **Partly Clogged**
